# Inspection Report

## DJs RV Services Marketing

**Property Address:**  
43316 Waymark Place  
Punta Gorda FL 33982

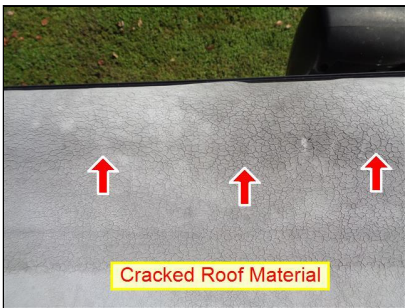
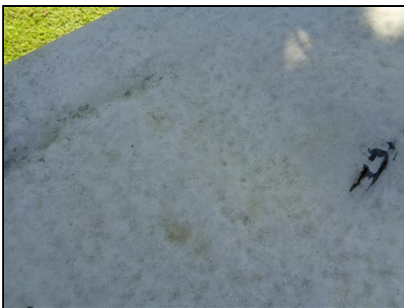
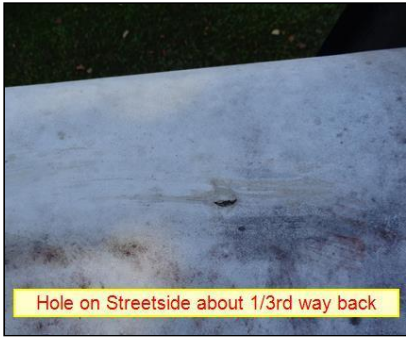
(2) Roof Inspection. Inspector viewed an area approx 2ft X 2ft that was rotted throughout back corner curbside. Suggest another inspection by a qualified RV technician take place to gauge amount of damage incurred.

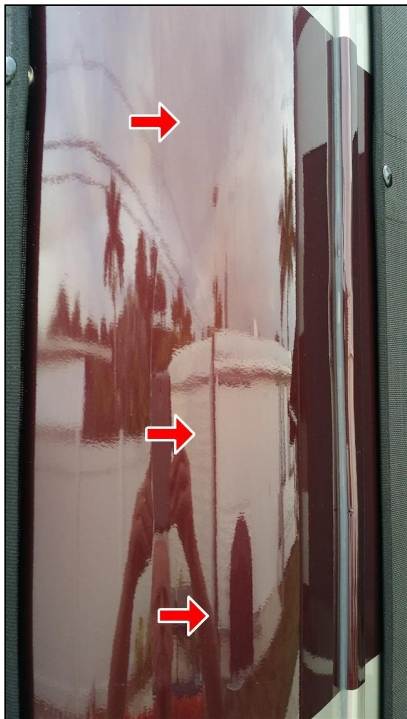
3.0.B Item 1(Picture)

Delamination Occurring. Recommend further inspection by qualified RV technician to discuss options.

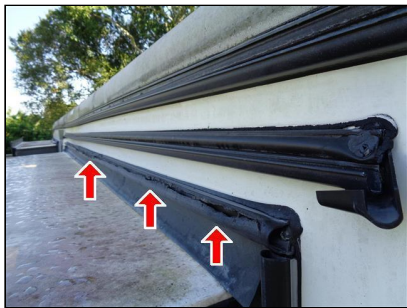
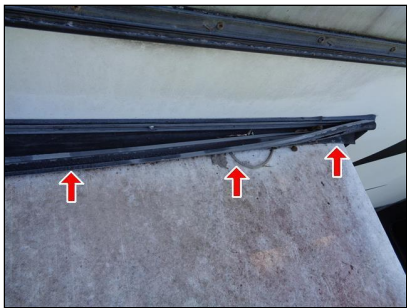
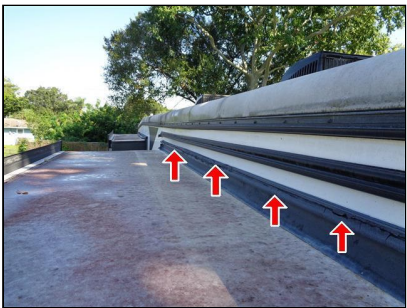
Molding Trip coming loose. Could cause water intrusion. Recommend further inspection by qualified RV Technician.

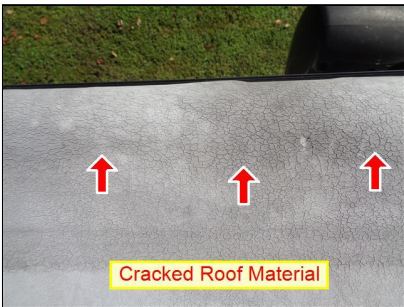
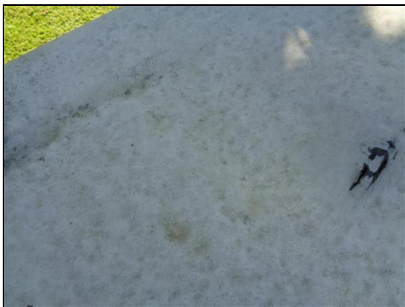
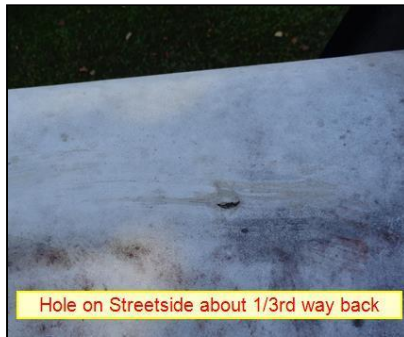
(2) Roof Inspection. Inspector viewed an area approx 2ft X 2ft that was rotted throughout back corner curbside. Suggest another inspection by a qualified RV technician take place to gauge amount of damage incurred.

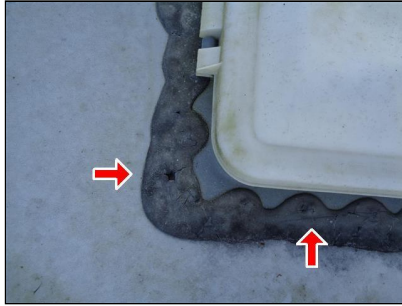
Skylights showing cracked sealant which could allow water intrusion. Recommend further inspection and or repair by qualified RV technician.

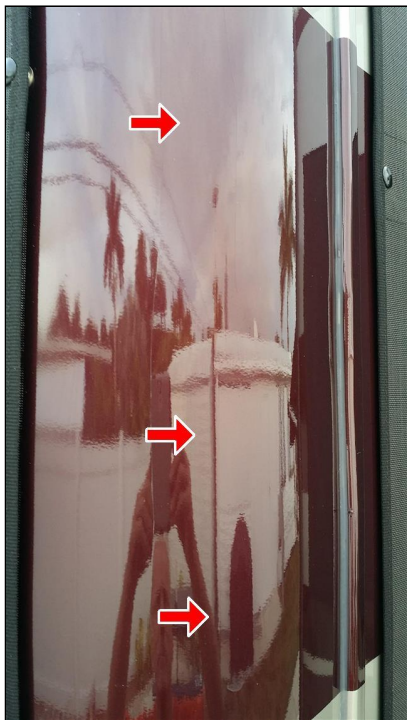
3.0.B Item 1(Picture)

**Comments:** Poor  
Delamination Occurring. Recommend further inspection by qualified RV technician to discuss options.

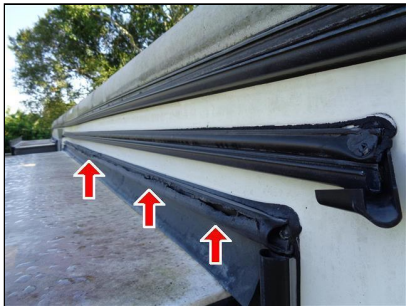
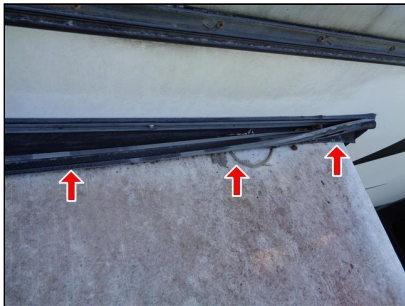
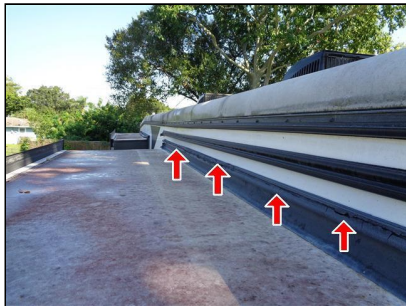
Molding Trip coming loose. Could cause water intrusion. Recommend further inspection by qualified RV Technician.

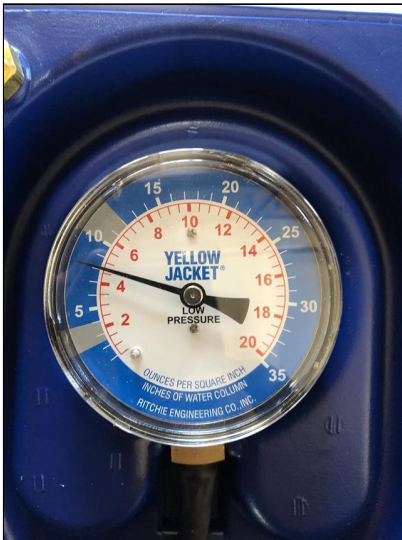
13.1 Item 1(Picture)

Image of Manometer 8" water Column for 3 minutes.

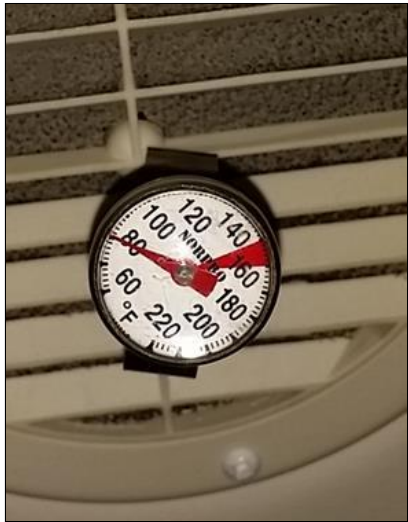
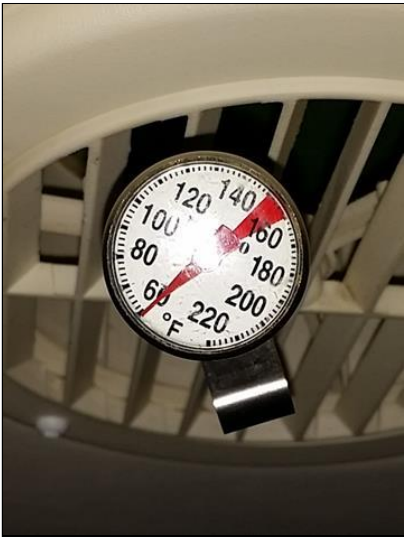
Comments: Acceptable  
AC Intake and Discharge Temperature

16.0 Item 1(Picture) Intake Temp

16.0 Item 2(Picture) Discharge Temperature
